## DISTRIBUTION CENTRE WARRINGTON, CHESHIRE

**Product:** Hambleside Danelaw Zenon Evolution Rooflights

**Contractor:** High Access Maintenance Limited

# CASE STUDY 24

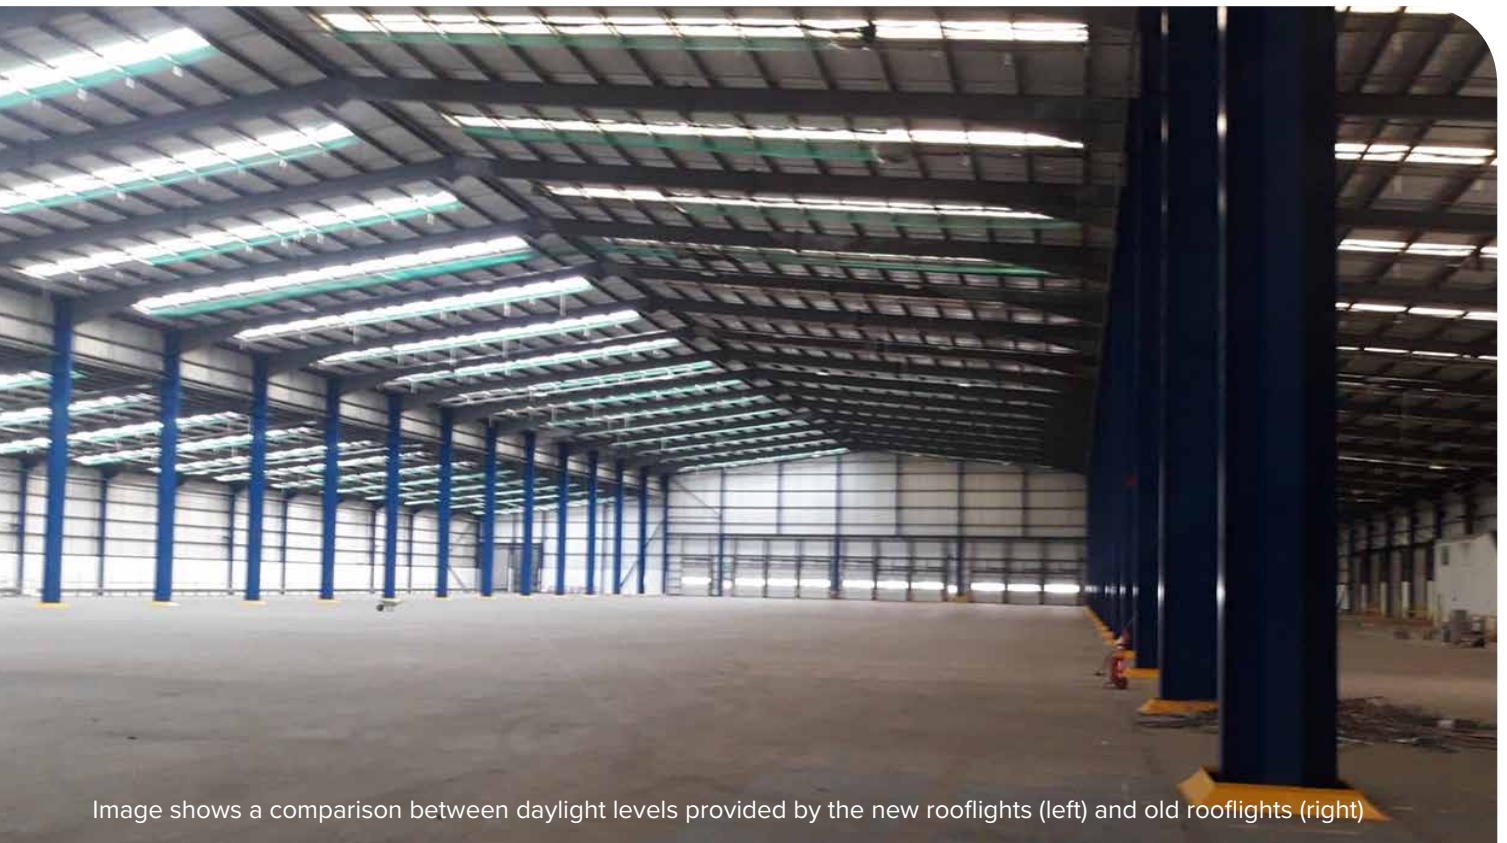
Image shows a comparison between daylight levels provided by the new rooflights (left) and old rooflights (right)

- Replacement of existing rooflights using GRP Evolution LC1 Class 3; 140 runs at 22m in length
- Grinding off all cut edge corrosion to all roof sheet laps
- Application of mastic and basecoat to the full roof – circa 8000m<sup>2</sup>
- Clearance of all guttering to low and high level roof areas and sealing of all gutter joints
- Thorough cleaning of all roof sheets
- MEWPs provided to accommodate all works safely

For the replacement of the 25+ year old outer sheet, the decision was to upgrade to the superior strength Zenon Evolution LC1. Unlike traditional GRP rooflights that are reinforced with short rovings, Evolution is formed using a continuous filament woven mesh of glass fibres providing very high tensile strength and resistance to tearing. This goes way beyond the minimum requirements for non-fragility. Due to the nature of the material this also means less resin is required within the manufacturing process compared to traditional reinforcement techniques, resulting in a significant reduction in embodied carbon in the finished product with no loss in performance.
